**Notes to accompany presentation on Fuel-gas
Involvement in Fire Causation. Presented at the
53rd Annual Northern Ohio Arson Seminar**

**February 26, 2022, at Ashland University,
Ashland, OH**

**Case Study involving house explosion soon
after a new propane tank replaced an
existing one.**

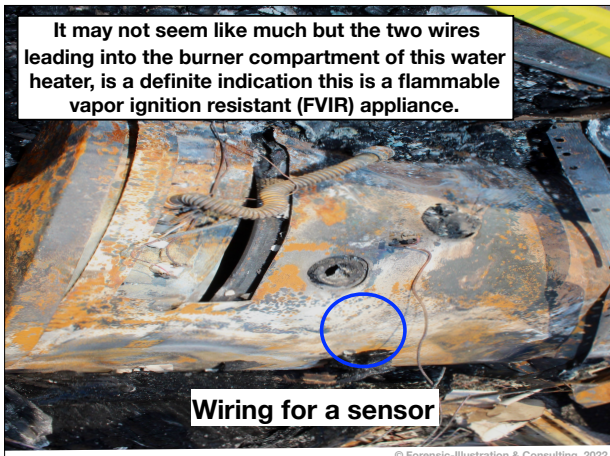
It may not seem like much but the two wires leading into the burner compartment of this water heater, is a definite indication this is a flammable vapor ignition resistant (FVIR) appliance.

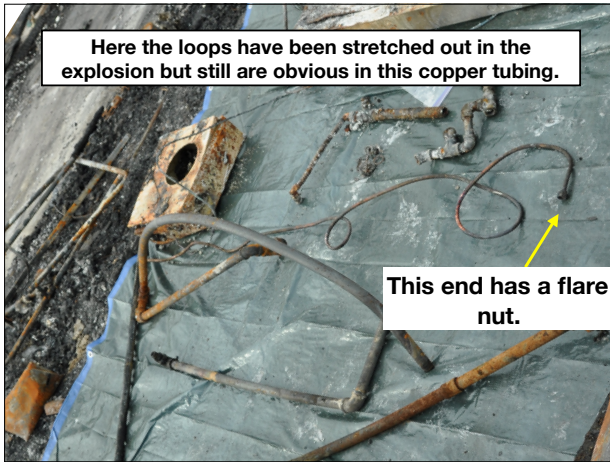
Here the loops have been stretched out in the explosion but still are obvious in this copper tubing.

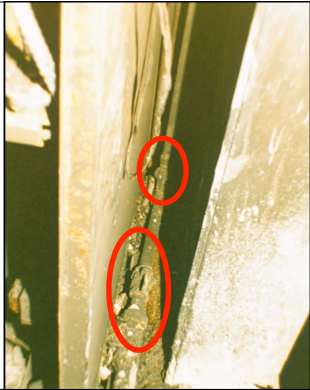
Two shutoffs in what appears to be one supply line are a clue that something is amiss.

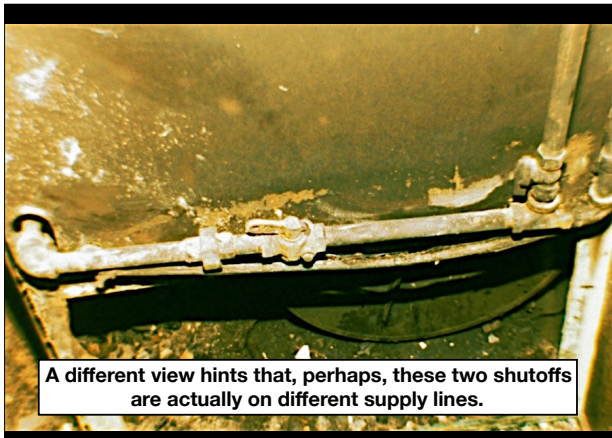
A different view hints that, perhaps, these two shutoffs are actually on different supply lines.

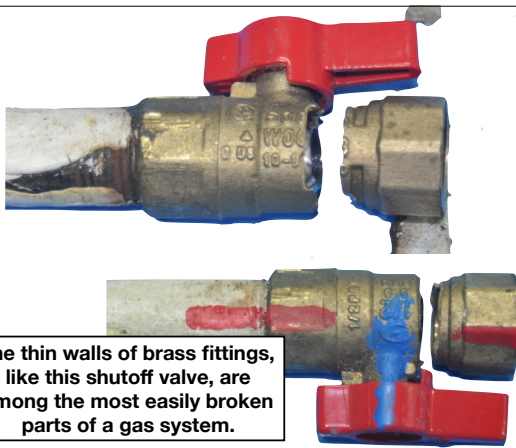
**The thin walls of brass fittings,
like this shutoff valve, are
among the most easily broken
parts of a gas system.**

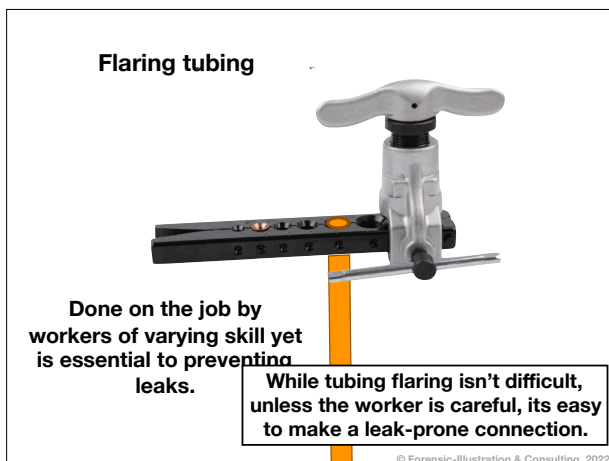
This connection has to be
REALLY tight or it will leak !

The leak path at a very slight
loosened flare fitting has a
directional leak path.

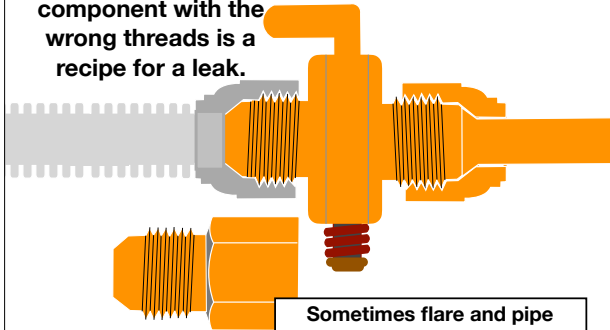
Slipping in an extra
component with the
wrong threads is a
recipe for a leak.

Sometimes flare and pipe
fittings are improperly
intermixed with leaks resulting.

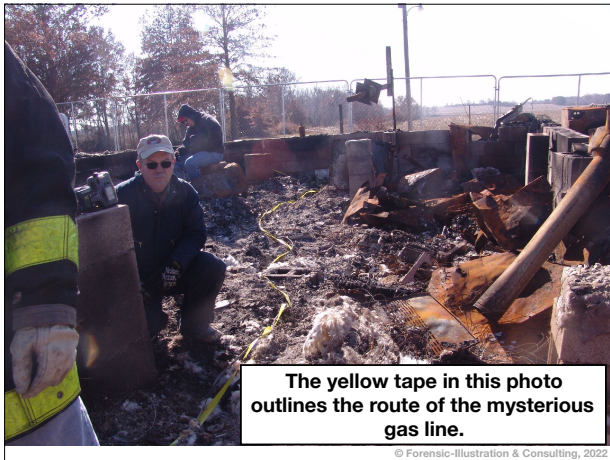
The yellow tape in this photo outlines the route of the mysterious gas line.

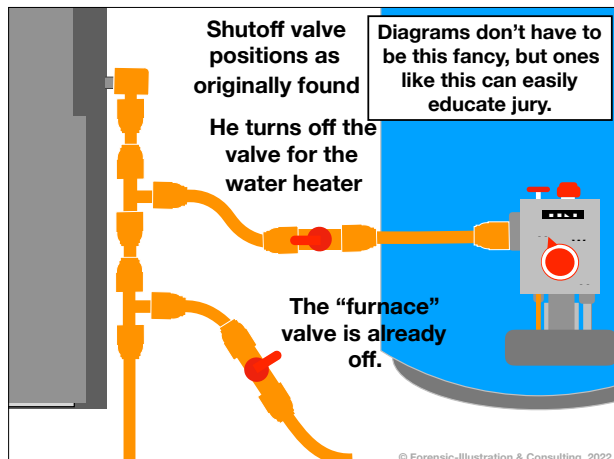
Shutoff valve positions as originally found

He turns off the valve for the water heater

The "furnace" valve is already off.

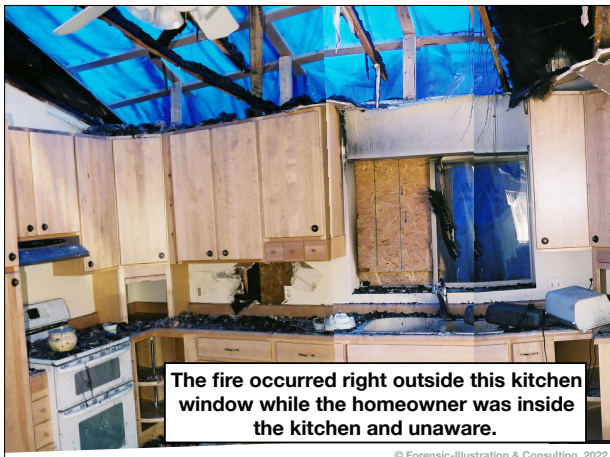
The fire occurred right outside this kitchen window while the homeowner was inside the kitchen and unaware.

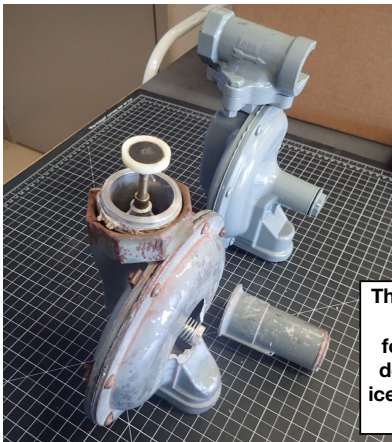
The gas regulator
shown in the
foreground was
destroyed when
ice fell off the roof
onto it.

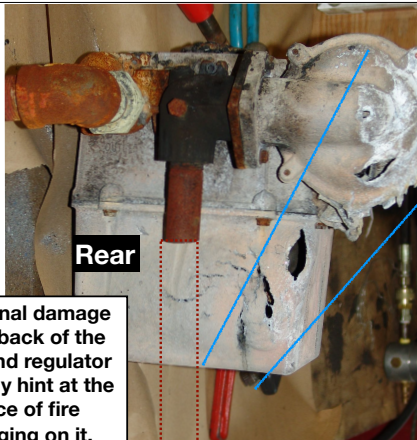
Rear

Directional damage
on the back of the
meter and regulator
assembly hint at the
source of fire
impinging on it.

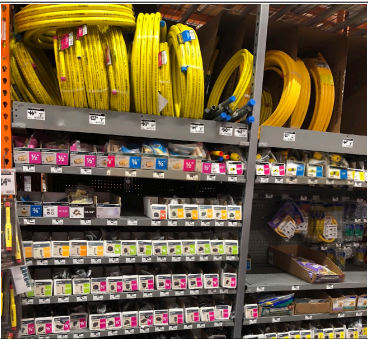
CSST fittings located immediately next to PE fittings at a "big box" home improvement store raise the possibility of them being intermixed with predictable leakage resulting.
